STATUS OF RECONSTRUCTION OF FRAGMENTED DIAMOND-ON-SILICON COLLECTOR FROM GENESIS SPACECRAFT SOLAR WIND CONCENTRATOR. M. C. Rodriguez¹, M. C. Calaway², J. H. All-ton³, K. M. McNamara³ and J. D. Hittle². ¹GeoControl Systems (ESCG) at NASA Johnson Space Center, Houston, TX, 77058, Melissa.Rodriguez-1@nasa.gov; ²Jacobs (ESCG) at NASA Johnson Space Center, Houston, TX; ³ NASA, Johnson Space Center, Houston, TX.

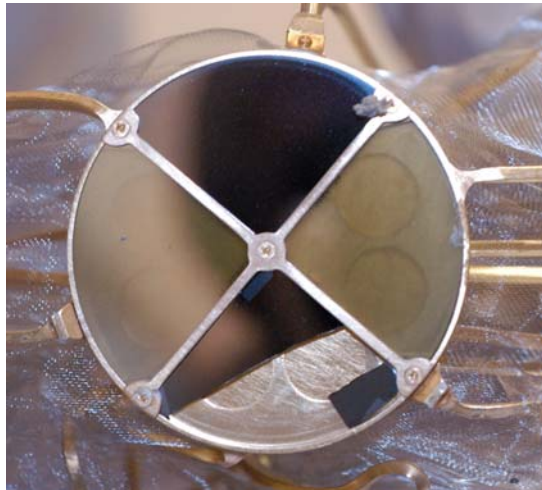
Fig. 1. Configuration of quadrants as removed from the concentrator in Utah. Additional fragments of the broken quadrant were recovered from the concentrator interior.

Condition of the Concentrator Targets as Recovered in Utah: The target quadrants, in a steel holder, were relatively protected inside of the concentrator, suspended on steel ribs and cushioned by steel mesh. After the concentrator was removed from the canister, the target holder with 3 intact targets and one broken target was extracted and stabilized for transport to Johnson Space Center in Houston. All loose pieces of collector fragments were carefully picked out of the concentrator, imaged and packaged separately.

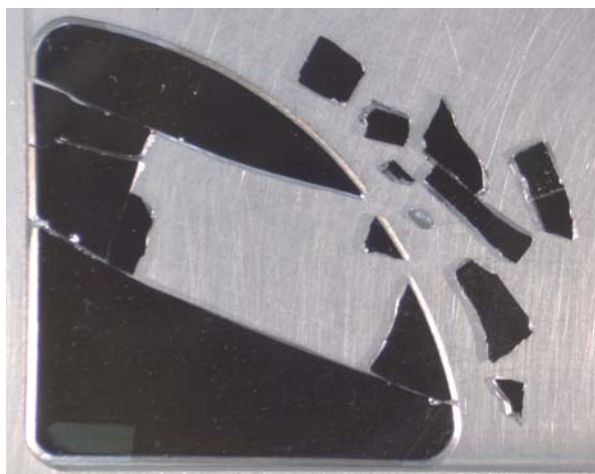
Fig. 3. DLC-on-silicon quadrant fragments fitted together, ambient illumination, Leica MZ9 microscope.

are shown in Figs. 2-4. Also shown are additional pieces recovered from the concentrator which are “very likely” to be target fragments, but their orientation cannot be established at this time. Table 2 compiles the sample numbers for “confirmed” and for “very likely” DLC-on-silicon target specimens.
